# Final Report

**St Lawrence Hazard Mapping LiDAR**

**South Nation River Conservation Authority  
38 Victoria Street, Finch, Ontario K0C 1K0**

**Airborne Imaging  
2700 – 61 Avenue SE  
Calgary, AB T2C 4V2**

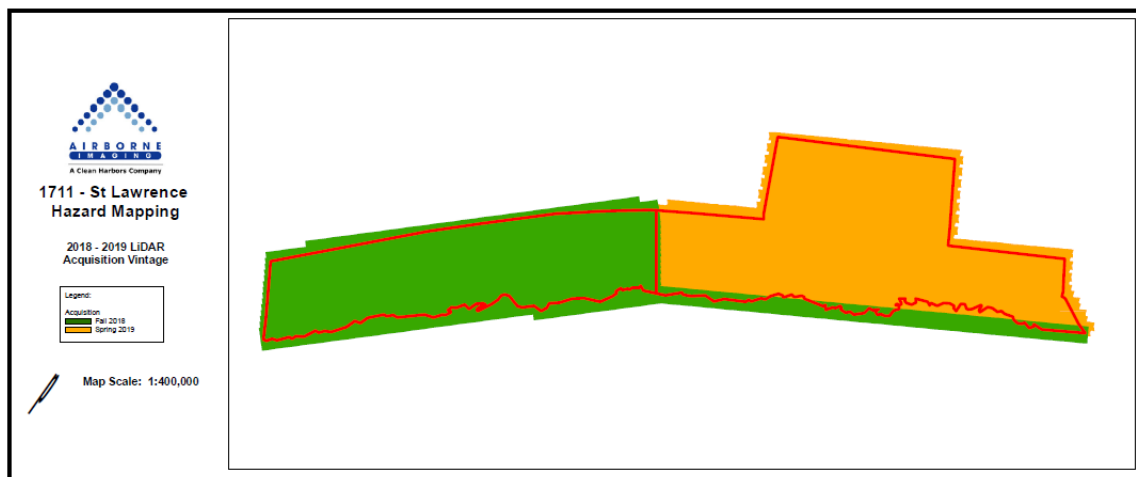
See map below for the areas covered during the acquisition season (2018 in green and 2019 in orange).

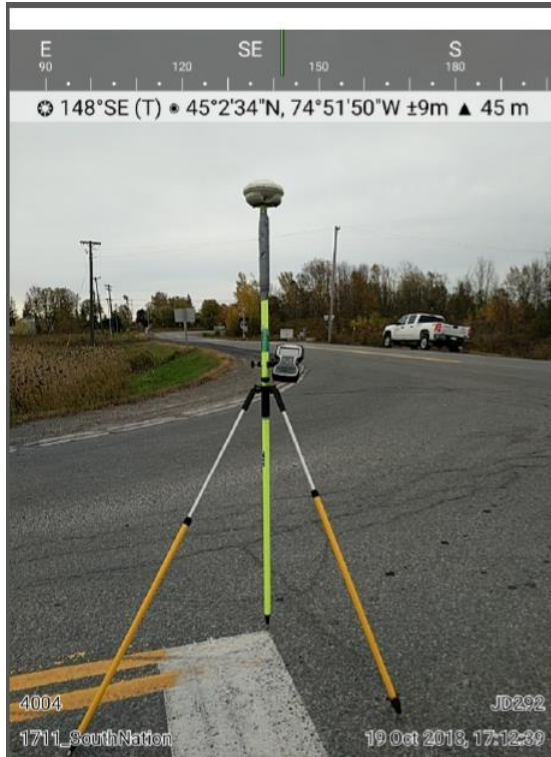
4004

9cm horizontal displacement

Horizontal accuracy was also determined through an examination directly from the LiDAR point cloud and using the horizontal check points that were collected for this project. Due to the resolution capabilities of the LiDAR point cloud only a subset of the surveyed check points could be used for this accuracy check. A listing of the check points used and the differences between surveyed/observations is provided in Appendix C. The actual graphical measurements are also provided in Appendix C.

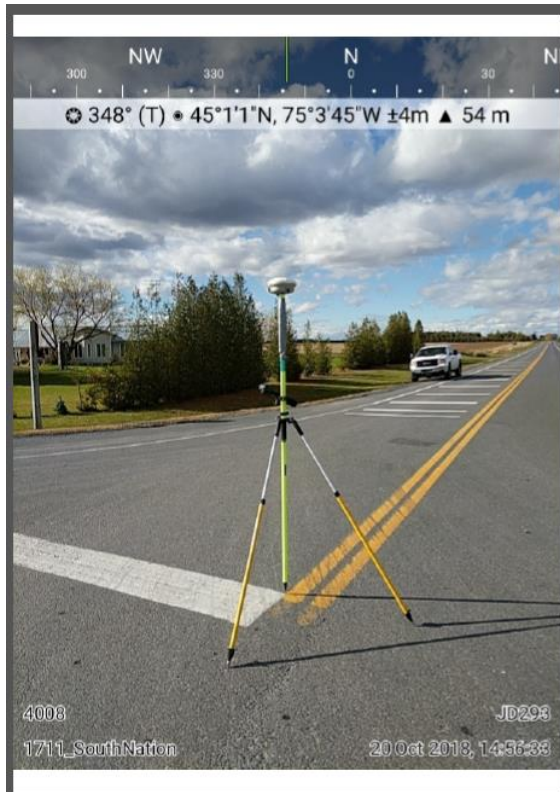
4008

2cm horizontal displacement

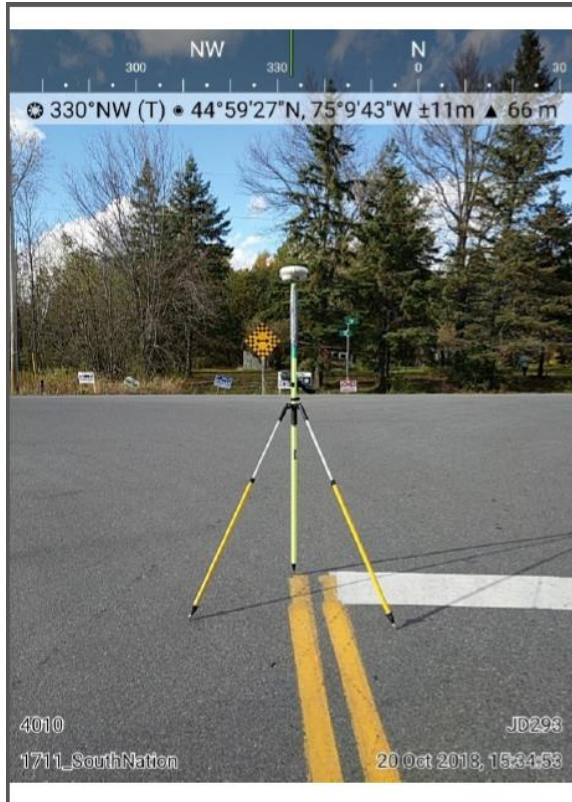
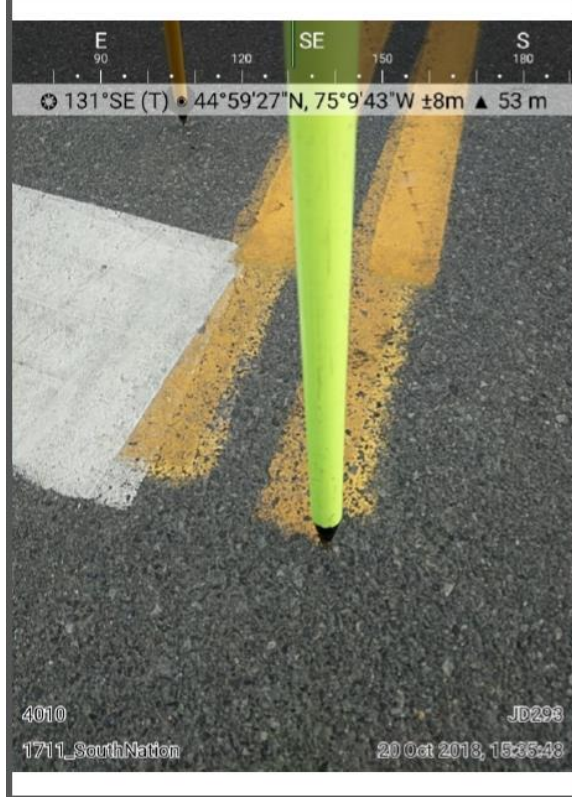
4010

4cm horizontal displacement

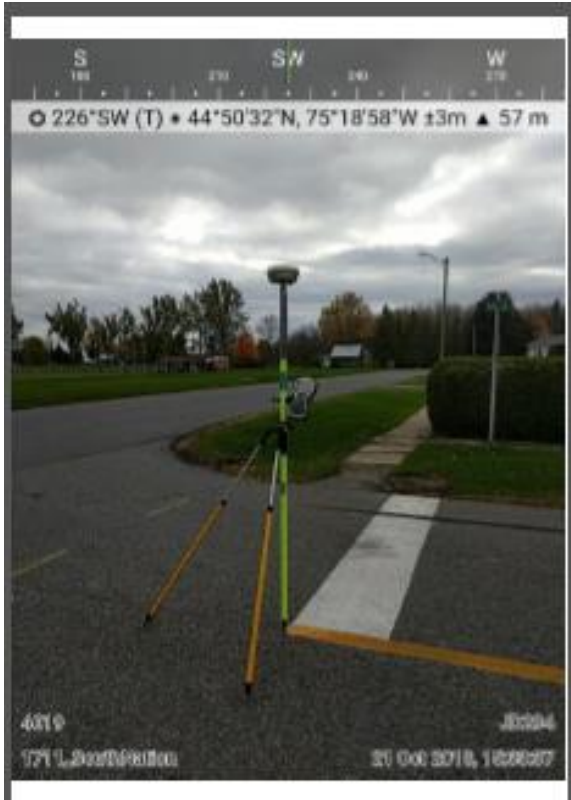
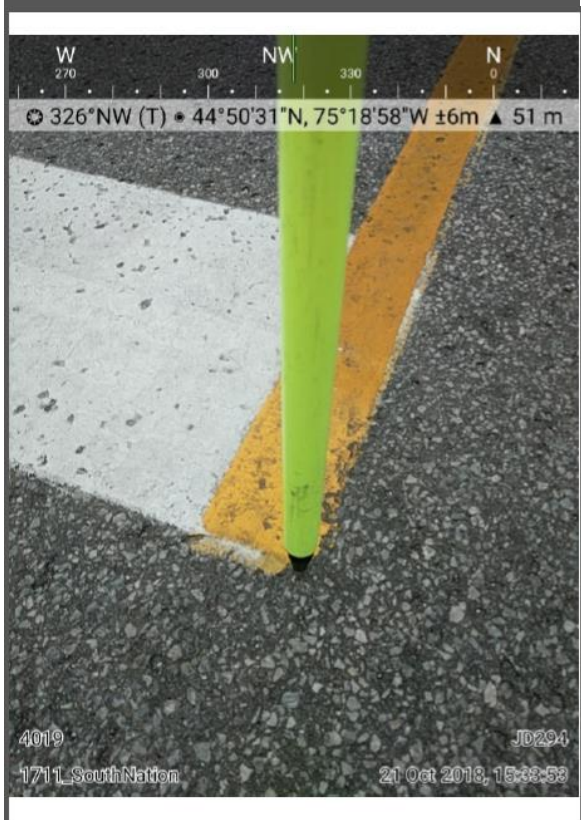
4019

11cm horizontal displacement

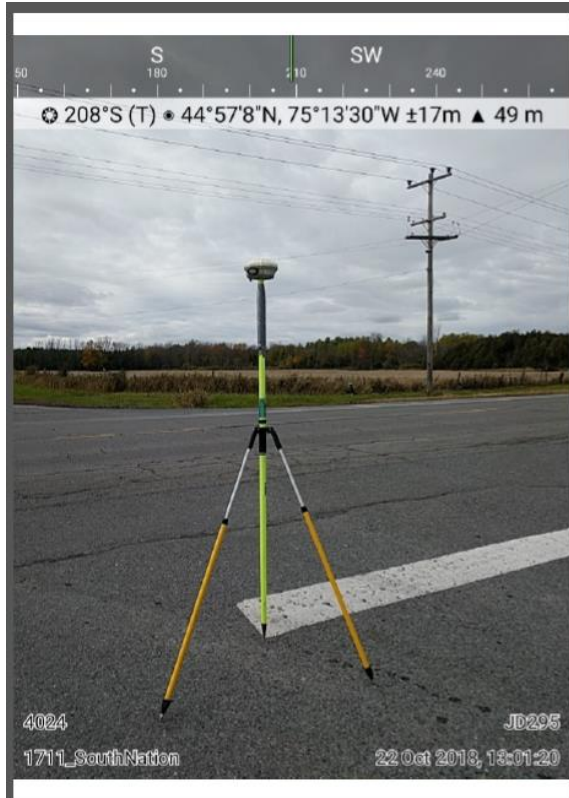
4024

6cm horizontal displacement

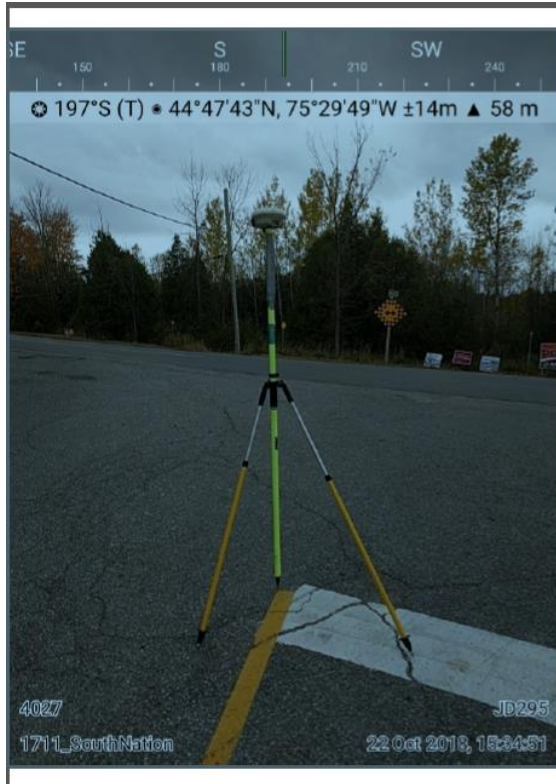
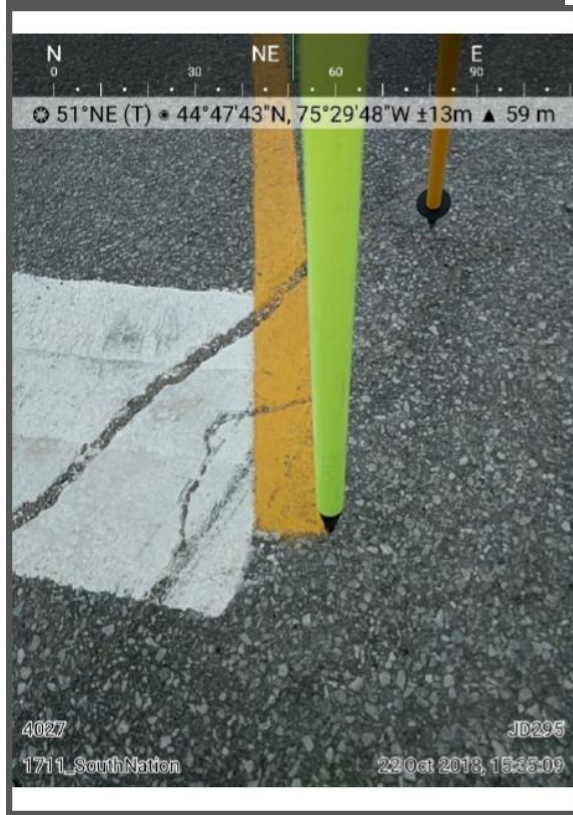
4027

9cm horizontal displacement

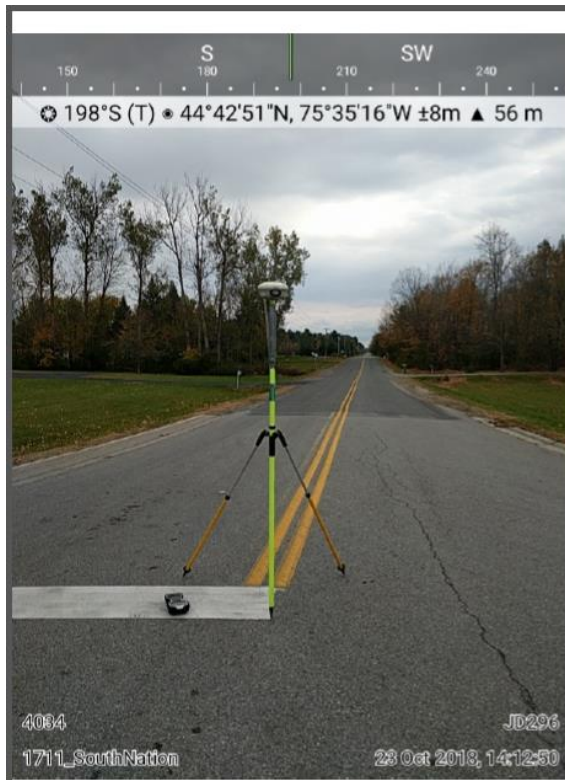
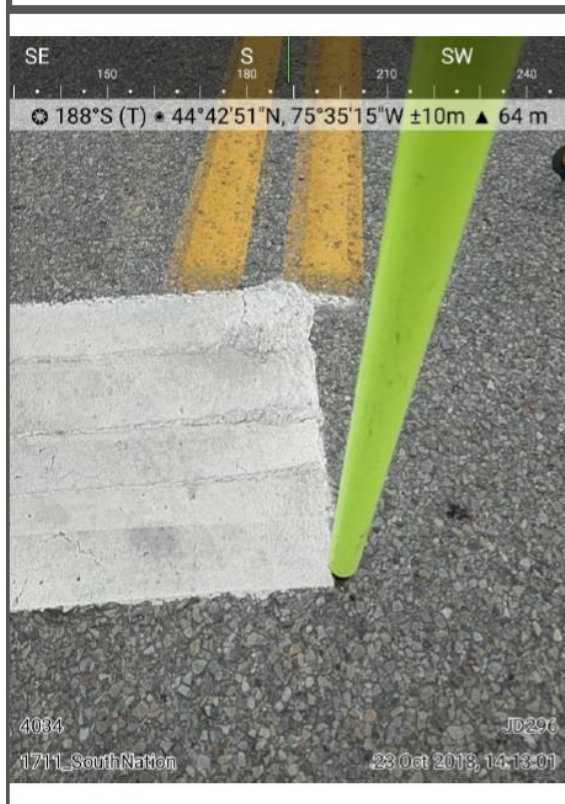
4034

8cm horizontal displacement

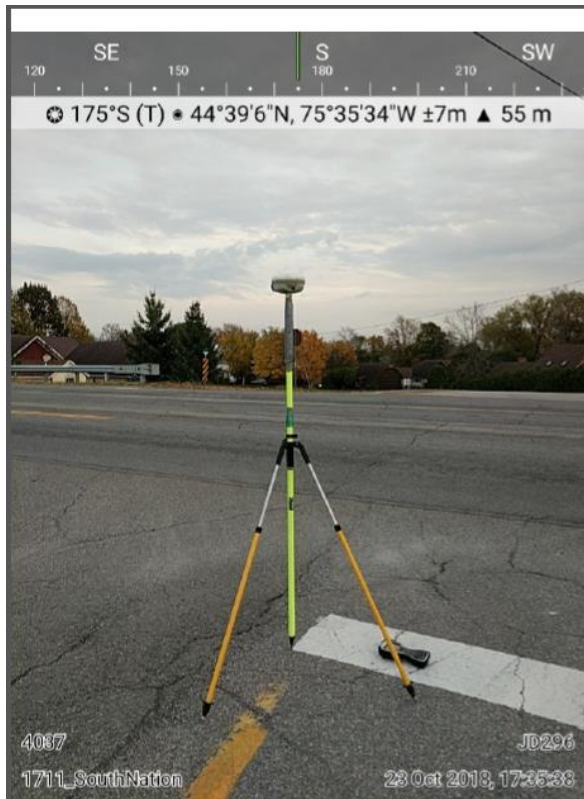
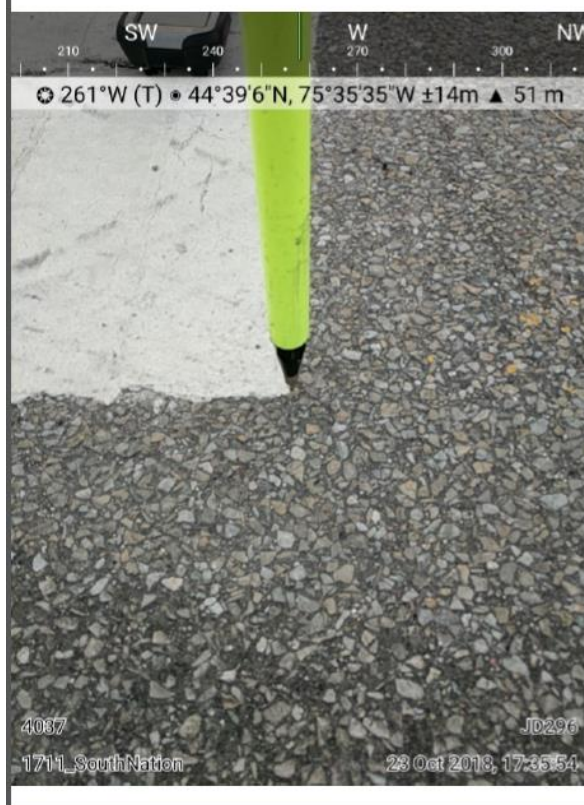
4037

8cm horizontal displacement
